RE: Construction Inspection Report for the Andeavor NGL Pipeline Project

72 PU-18-72 Filed 02/15/2019 Pages: 23
Construction Inspection Report
Wenck Associates, Inc.
Sara Simmers, Envir. Scientist

Andeavor NGL Pipeline Project Construction Inspection Report PU-18-72

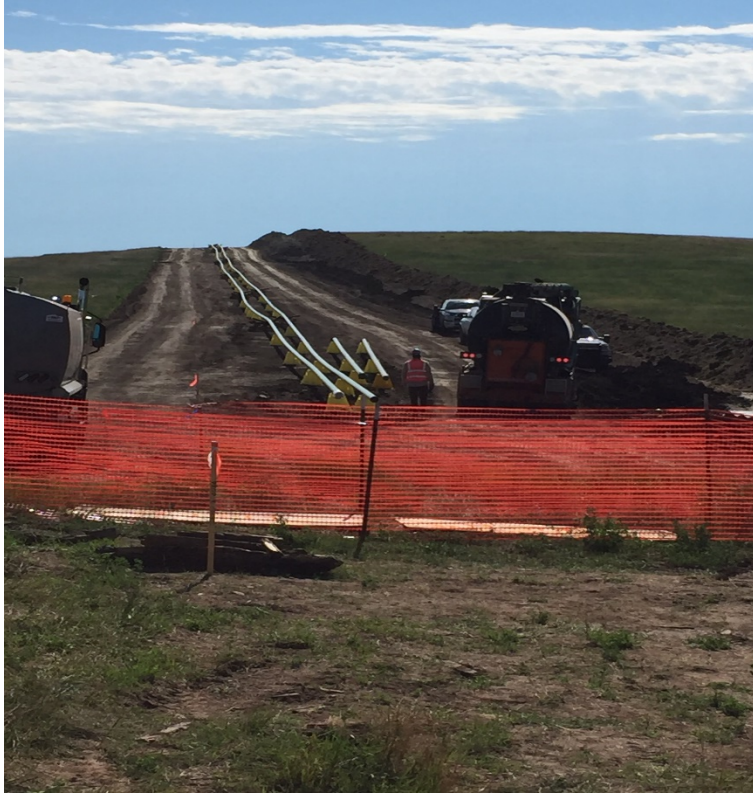
The first construction inspection was conducted on 12 July 2018 at the Fryburg Rail Segment where Jones Contractors were working. Wenck staff met with Shafer construction manager Scott Staehnke on site to witness trenching work. Two excavating machines were used to dig the trench alongside the assembled pipe. These excavators used wooden mats to cross 132nd Ave SW in order to minimize soil disturbance along the gravel road's shoulder. The road crossing remained unexcavated as horizontal boring was used to install the pipe underneath the road. Spotters observed the machines as the trench was dug and trench spoils placed on either side of the pipe. The depth of the pipeline installation was verified to have at least 48 inches of cover. Mr. Staehnke mentioned the spoil piles help create a barrier around the trench which limits the risk of workers slipping into the excavated area. Placing the trench spoils on both sides of the trench also reduced the chance of subsoils mixing with already stripped and stored topsoils positioned on the south side of the ROW. Even with these precautions, there was a slight overlapping of the spoil pile with the segregated topsoil and the occasional chunk of soil that rolled out of the ROW. These issues were very minimal and any soil chunk that left the ROW was immediately removed by the machine spotters. On the gravel road, some sediment tracking was witnessed as the machines crossed. Jones Contractor employees were quick with a shovel to remove any sediment tracked out of the ROW. When backfilling the trench, a sifter attachment was used on an excavator to apply debris free soil onto the installed pipe and ensure proper backfilling around the pipe while preventing damage to the coating. (**Appendix A, Photos 1-3**).

Photo 1. Point: 7. Facing: East. Location: 46.8596, -103.23127. Topsoil on outside (right) with the subsoil pile touching. Fencing located around bore exit hole.

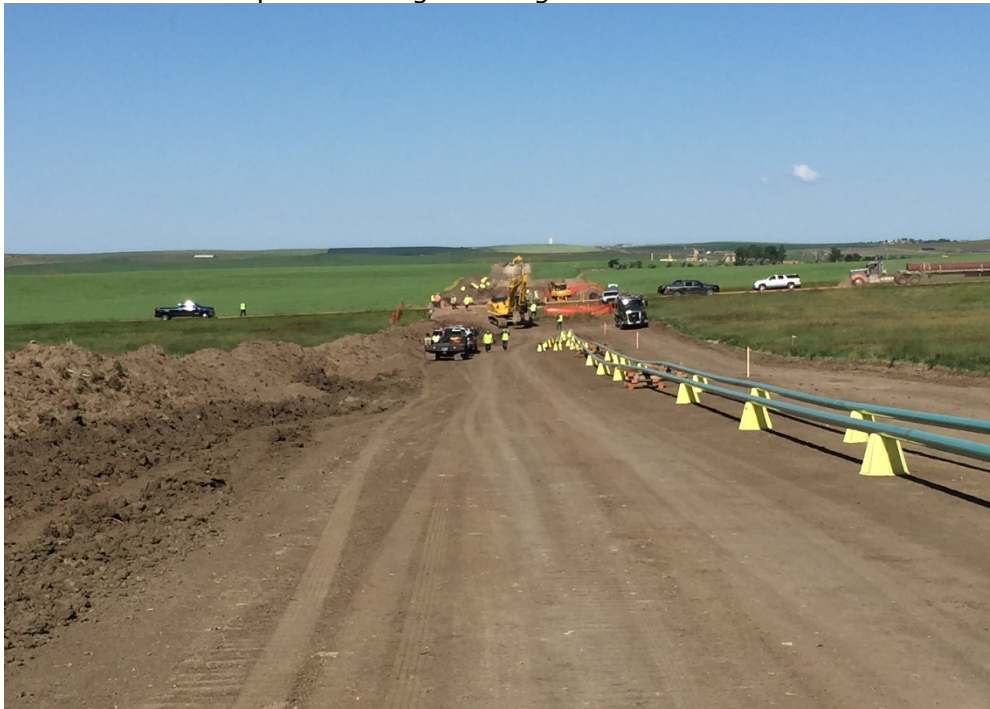
Photo 2. Point: 8. Facing: West. Location: 46.8594, -103.2294. View of road crossing at 132nd Ave SW where minor sediment tracking occurred due to vehicle crossing. Equipment staged along the road within the ROW at a designated staging area.

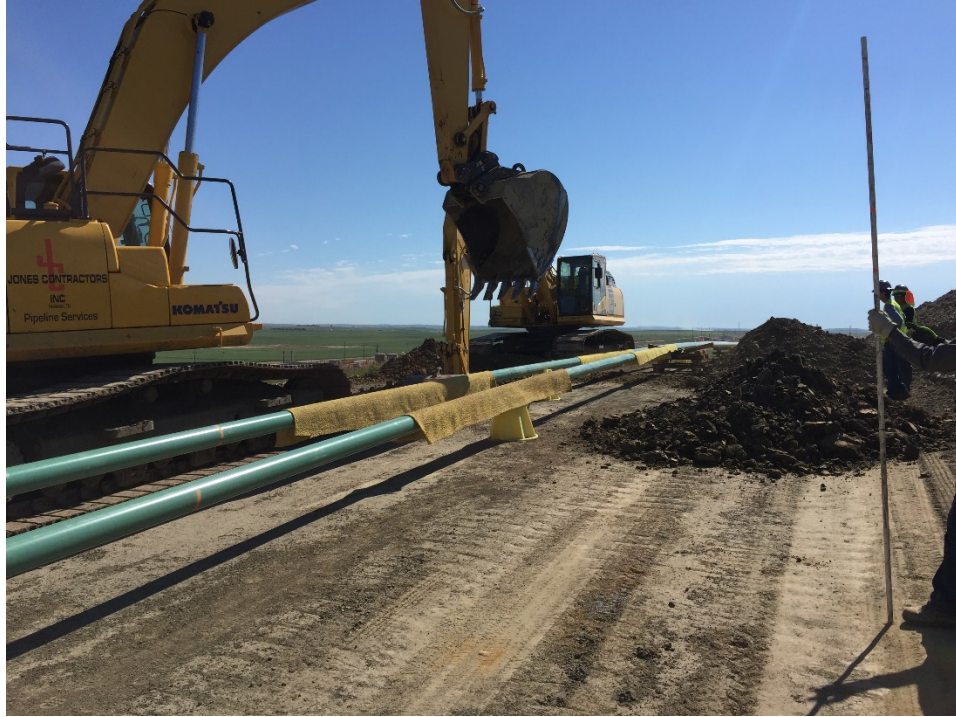
Photo 3. Point: 9. Facing: Northeast. Location: 46.8592, -103.2187. Trenching operations. Piping properly staged upon risers with protection blankets to prevent damage from falling sediment.

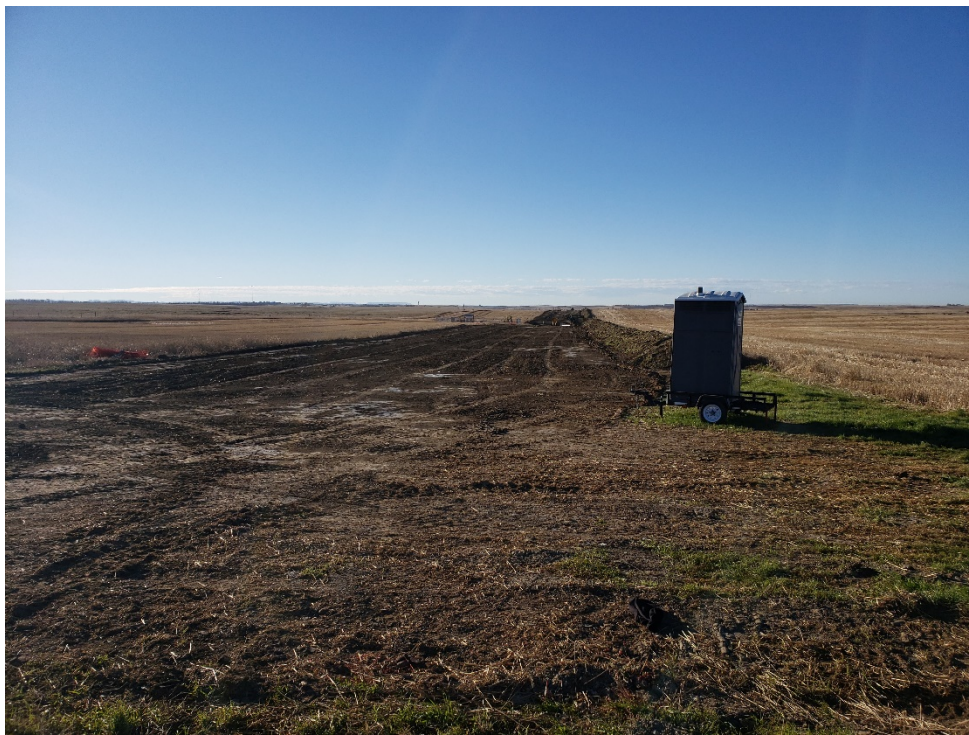
the inspection. The graders were positioned on either side of 32nd St SW separately spreading the topsoil. As mentioned in the topsoil report, the final pass made during initial topsoil removal will always disturb some subsoil. Topsoil is not uniformly even across a landscape and slight subsoil disturbance is unavoidable when trying to ensure all topsoil has been stripped. The soil disturbed in the final pass of topsoil removal was strategically pushed to the bottom of the topsoil stockpile. This allows graders to spread this layer first when reapplying the stored soils. This procedure was witnessed at the time of the inspection by both machine operators and the completed reapplication of topsoil appeared to be free of subsoil discoloration (**Appendix A, Photos 4-5**).

Photo 4. Point: 14. Facing: South. Location: 46.9483, -103.2113. Location on South Segment where topsoil is ready to be re-spread.

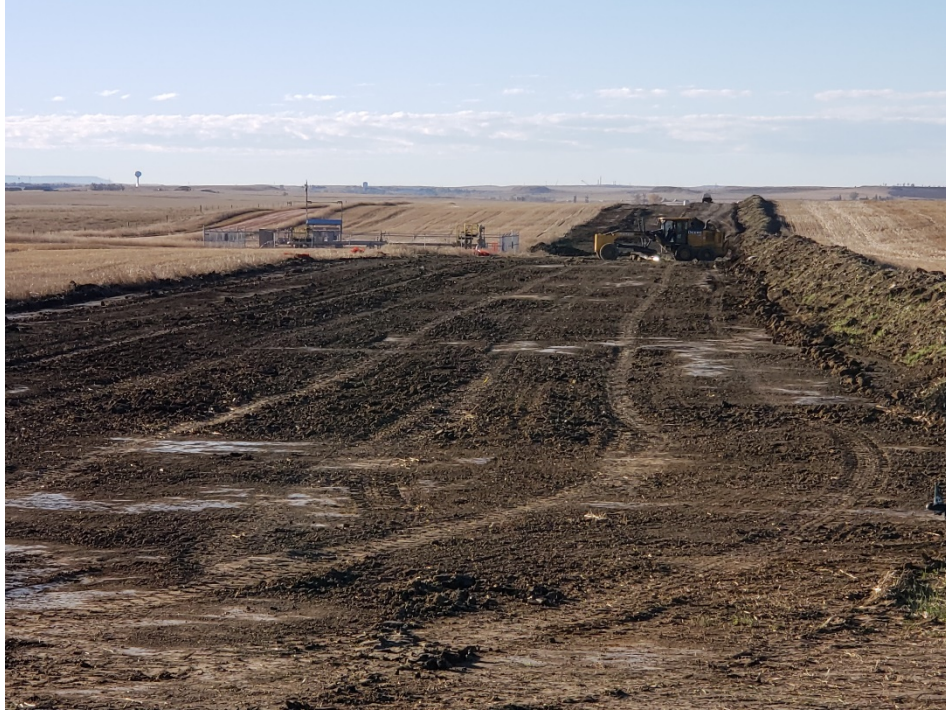
Photo 5. Point: 15. Facing: South. Location: 46.9487, -103.2125. Grader spreading the first layer from the stockpile containing any mixed sub/topsoil according to planned procedure. Pipeline gauge for a different pipeline located to the east of ROW.

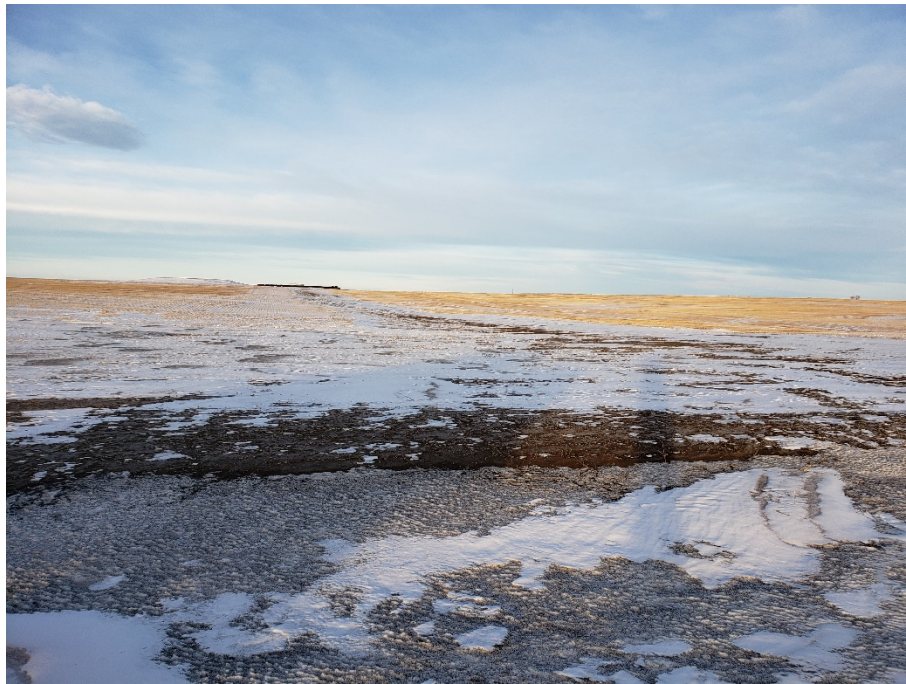
The final construction inspection was completed on 1 February 2019 at the Fryburg Rail Segment and the South Segment. Topsoil was reapplied throughout these two segments and evidence of reseeding was witnessed. Snow cover impeded the view of some of the pipeline scar but soil color and plant sprouts were visible. Both areas appeared to be planted with the same seed mix. According to Craig Kitchens, Shafer construction manager, a native seed mix was used and there may be some final seeding work completed in the spring. The plants were growing in noticeable rows indicating even germination and the start of good establishment. Plant growth will be monitored during the as-built inspections which will be conducted in the spring. Surface soil color appeared consistent with topsoil and the initial growth of the planted seeds speaks to proper topsoil reapplication in these areas (**Appendix A, Photos 6-9**).

Photo 6. Point: 18. Facing: West. Location: 46.8700, -103.2528. View of pipeline scar leading to Fryburg Rail Terminal. Surface soil color was topsoil. Contouring matched surrounding landscape.

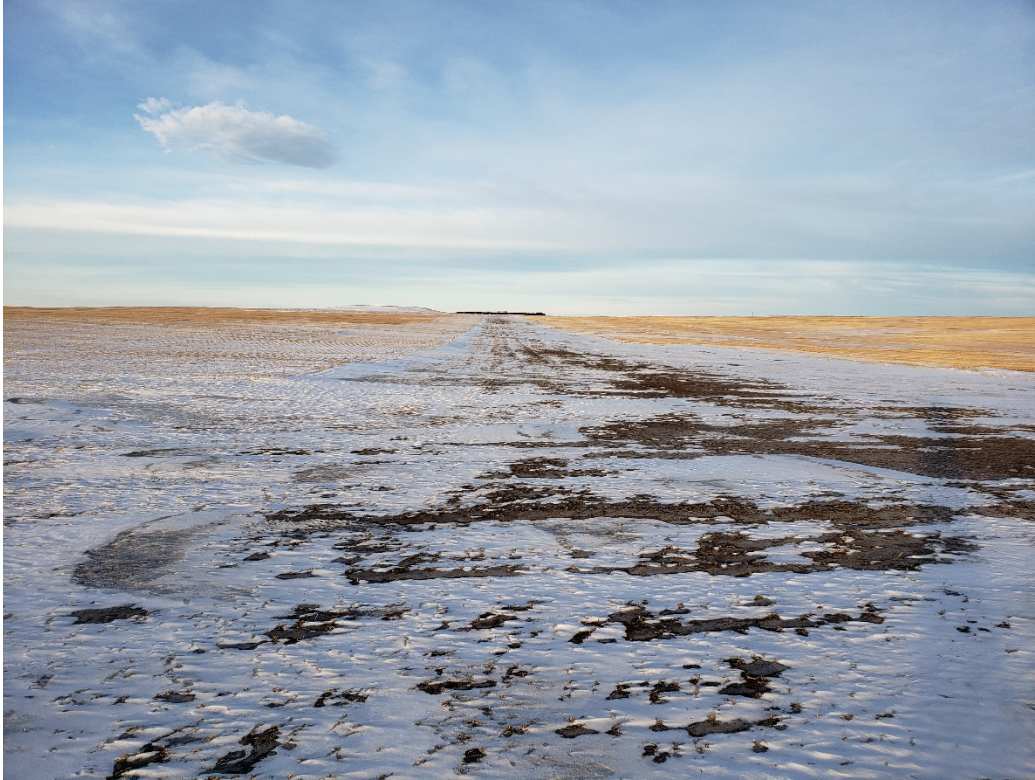
Photo 7. Point: 19. Facing: West. Location: 46.8723, -103.2598. Sprouting vegetation along Fryburg Rail segment in foreground. Rows of vegetation along scar in the background.

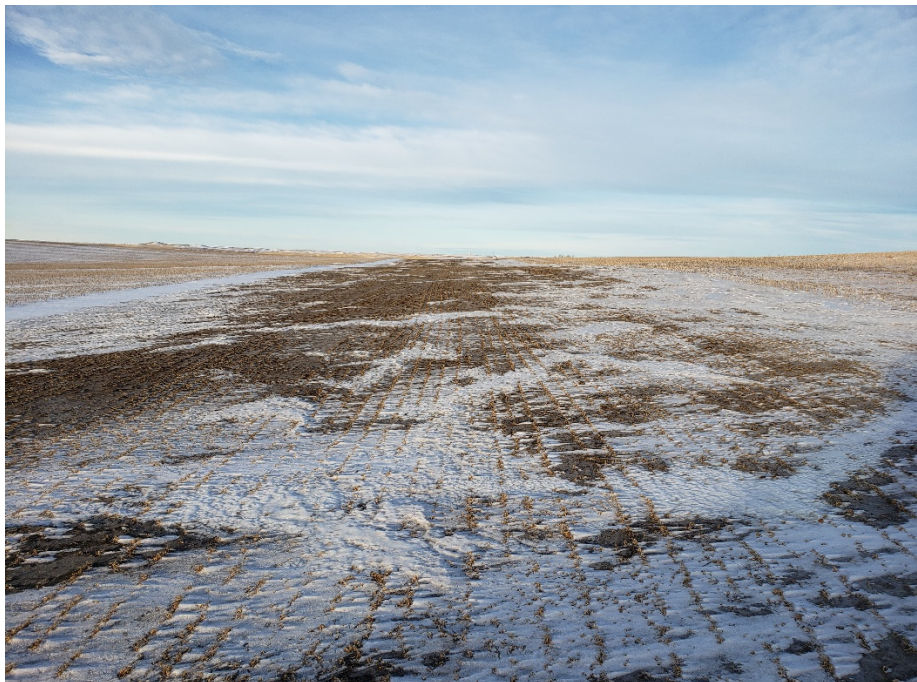
Photo 8. Point: 20. Facing: North. Location: 46.9794, -103.2150. Evidence of seeding along pipeline scar. Germination appeared even.

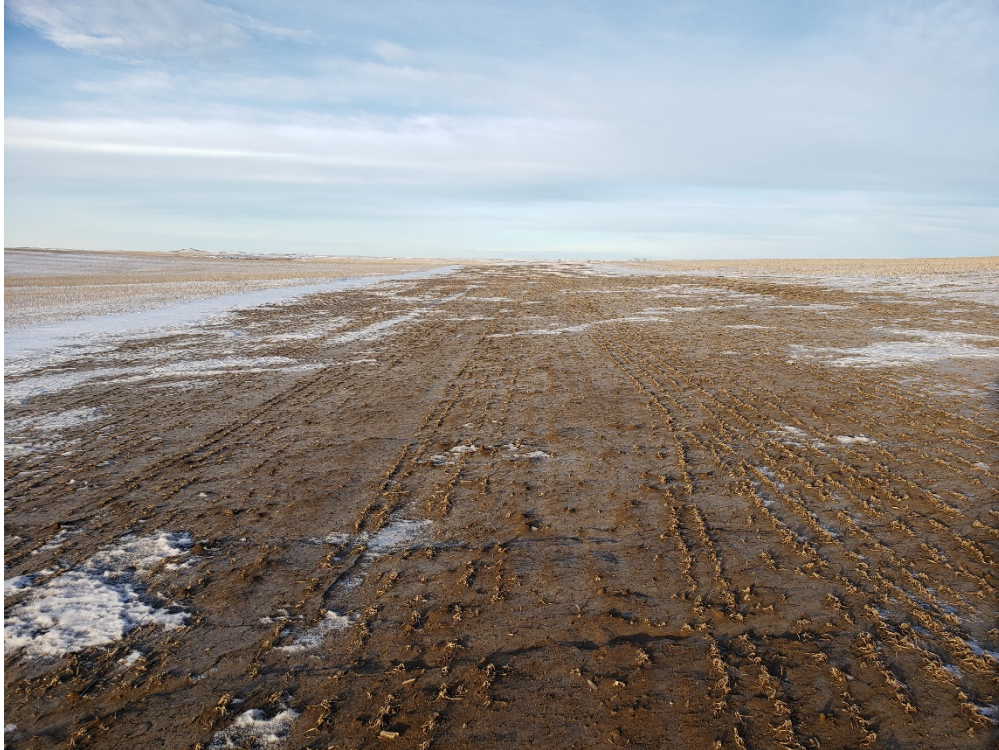
Photo 9. Point: 21. Facing: South. Location: 46.9782, -103.2122. Vegetation appears to have taken after fall planting.
